# Core build-up using a dual-curing composite and treatment with all-porcelain restorations

Dr Jürgen Manhart presents a case report demonstrating core build-up using a core composite and subsequent permanent treatment with glass porcelain restorations

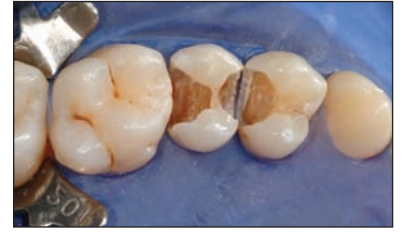
Figure 3: After placing the rubber dam

(Figure 2). Due to the proximity of the defect to the pulp at tooth 25, a rubber dam was placed as a prophylactic measure before excavation of the caries to prevent any infection from the saliva, if the pulp chamber were to be exposed (Figure 3). The palatal cusp of the second premolar, which had a large undercut, fractured during removal of carious tooth structure (Figure 4). Further removal of the caries resulted in a small, pinpoint perforation of the pulp at the buccal cusp (Figure 5). The situation was explained to the patient and, as there was no evidence of tooth pain, the exposed pulp was capped directly. After cleaning and disinfecting the surface with a 3% hydrogen peroxide solution, a permanently soft calcium hydroxide

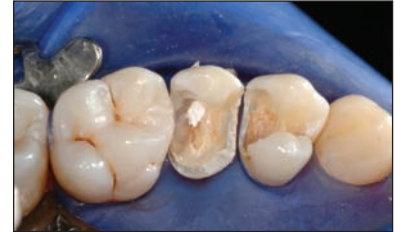
Figure 6: After explaining the situation to the patient, the pulp was capped directly. First an aqueous calcium hydroxide suspension was applied to the perforated area

solution was applied to the perforated area (Figure 6) and adapted carefully using a small, clean cotton pellet (Figure 7). The area was completely covered with a hardening calcium hydroxide solution and, because of the extent of the caries the mesial surface of the first premolar was included in the cavity preparation (Figure 8). After placing a steel matrix around the extensive defect at tooth 25 for the subsequent build-up (Figure 9), a 37% phosphoric acid gel was first applied selectively to the enamel margin of the cavity (Figure 10).

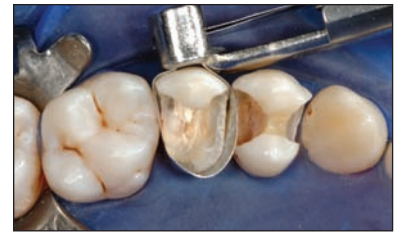
Figure 9: Placing a steel matrix at tooth 25

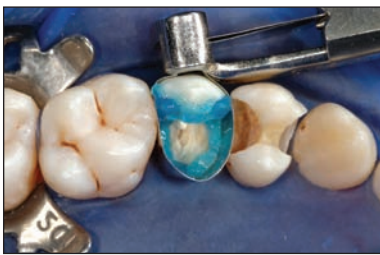
Figure 10: A 37% phosphoric acid gel was first applied selectively to the enamel of the cavity margins

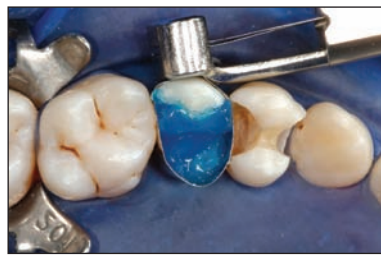
Figure 11: After approx. 15s the whole cavity was filled with etching gel and the enamel and dentin were conditioned for a further 15 s (total etch)

the total-etch technique (Figure 11). After thoroughly rinsing off the etching gel and loosened fragments of tooth structure using the compressed air and water spray (Figure 12), the cavity was carefully dried using oil-free compressed air (Figure 13). It is essential to avoid overdrying the dentin at this stage, as this would result in the collapse of the three-dimensional woven collagen fibers in the conditioned dentin, making it extremely difficult for the subsequent adhesive application to penetrate, with the risk of a poor bond and increased risk of postoperative sensitivity.

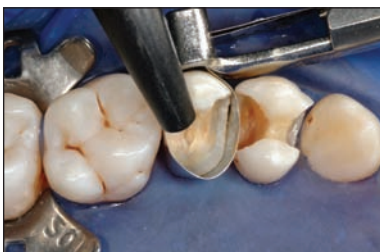
Figure 13: The cavity was carefully dried with oil-free compressed air. It is essential to avoid over-drying the dentin

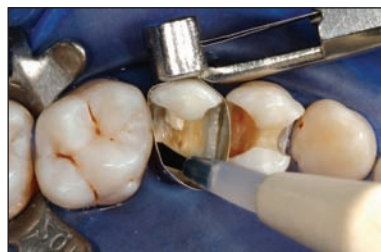
Figure 14: Application of Solobond Plus primer (Voco) to the enamel and dentin for 30 s using a disposable brush

The primer of the Solobond Plus adhesive system (Voco) was applied to the enamel and dentin with a disposable brush and massaged into the dentin for 30 seconds (Figure 14). After

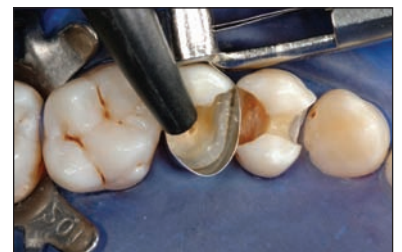
Figure 15: Excess is carefully blown off using oil-free compressed air

blowing off the excess carefully and evaporating the acetone solvent using oil-free compressed air (Figure 15), adhesive was applied uniformly to all the prepared enamel and dentin surfaces with a new disposable brush and massaged in for 15 seconds (Figure 16). The adhesive was then finely dispersed and thinned to form a uniform film (Figure 17). The adhesive was cured for 20 seconds using a halogen lamp (Figure 18).

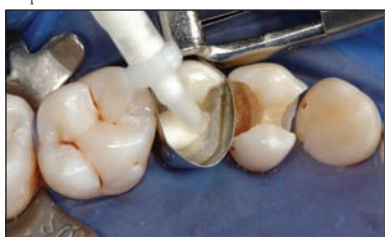
Figure 19: Filling the defect with a dual-curing core composite (Rebuilda DC, Voco) from the mini-cartridge using an angled application tip with a 360° rotation

A white shade of Rebilda DC dual-curing core composite (Voco) was applied directly into the defect from the mixing tip of the cartridge system, to which an angled intraoral tip with a 360° rotation can be attached (Figure 19).

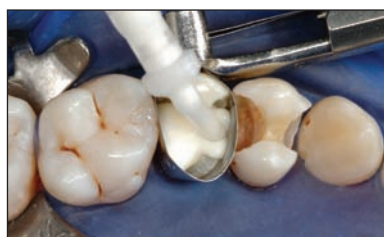
Figure 20: The cavity was slowly and carefully filled with core material avoiding the inclusion of air bubbles

bubbles (Figure 20). Figure 21 shows the defect completely filled with core composite. The dual-curing core composite was light-cured for 40 seconds using a halogen lamp (Figure 22). The first premolar was then built up using the same procedure as described above (Figures 23-36).

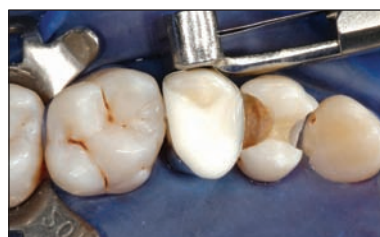
Figure 21: The defect completely filled with core composite

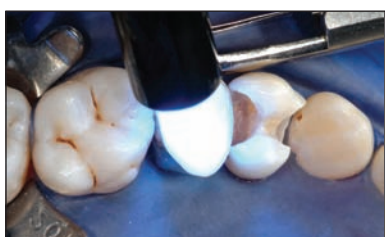
Figure 22: The surface of the dual-curing core composite was light-cured for 40 s using a light-curing lamp

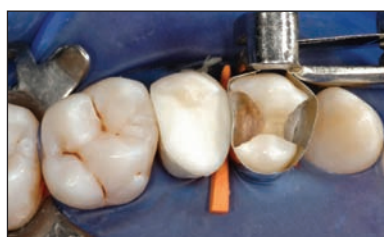
Figure 23: Placing a steel matrix at tooth 24

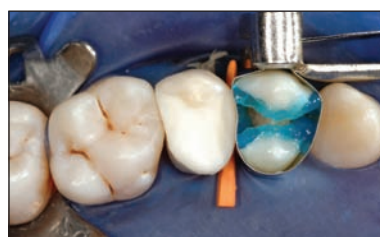
Figure 24: A 37% phosphoric acid gel is first applied selectively to the enamel of the cavity margins

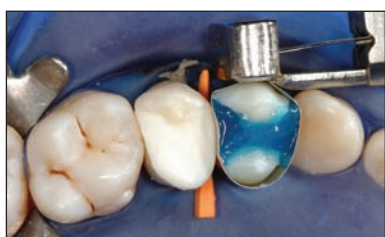
Figure 25: After approx. 15 s the whole cavity was filled with etching gel and the enamel and dentin were conditioned for a further 15 s (total etch)

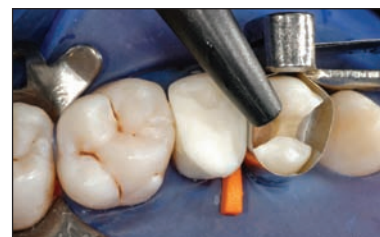
Figure 27: The cavity was carefully dried with oil-free compressed air. It is essential to avoid overdrying the dentin

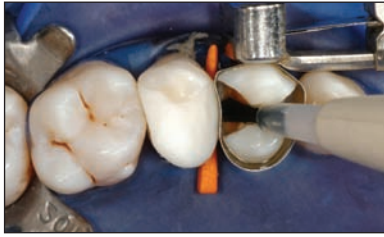
Figure 28: Application of Solobond Plus primer (Voco) to the enamel and dentin for 30 s using a disposable brush

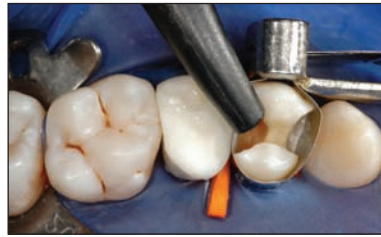
Figure 29: Excess was carefully blown off using oil-free compressed air

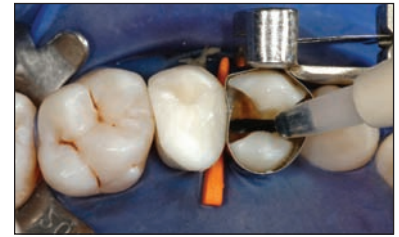
Figure 30: Application of Solobond Plus adhesive (Voco) to the enamel and dentin for 15 s using a disposable brush

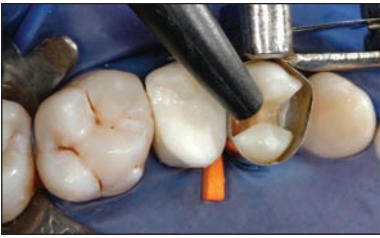
Figure 31: Excess was carefully blown off using oil-free compressed air

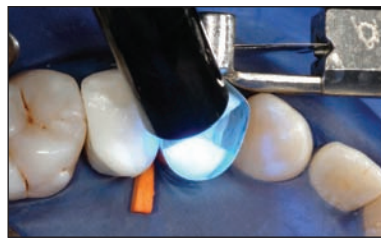
Figure 32: The bonder was light-cured for 20 s

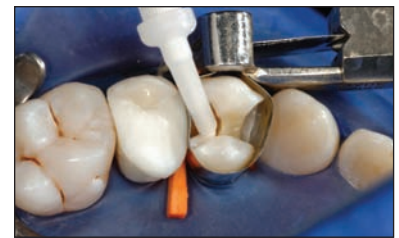
Figure 33: Filling the defect with a dual-curing core composite (Rebilda DC, Voco)

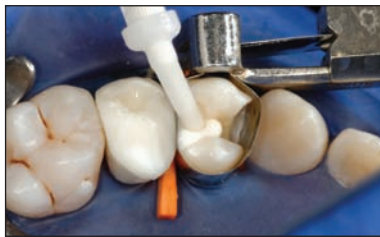
Figure 34: The cavity was slowly and carefully filled with core material avoiding the inclusion of air bubbles

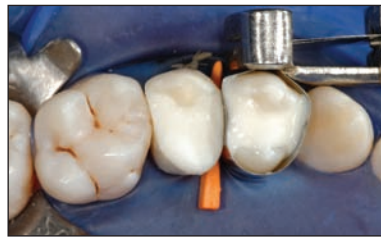
Figure 35: The defect completely filled with core composite

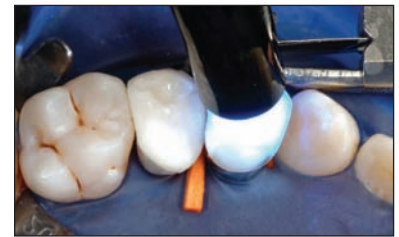
Figure 36: The surface of the dual-curing core composite was light-cured for 40 s using a light-curing lamp

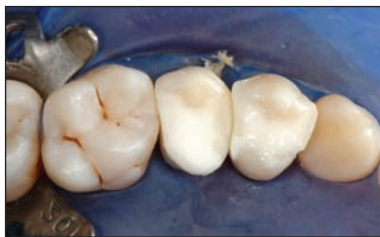
Figure 37: After removal of the matrix

After removing the matrices, but before removing the rubber dam, the build-up was checked again to ensure that it was not short in any area and that there were no marginal gaps (Figure 37). Figure 38 shows both core build-ups before trimming. The cores were trimmed and all excess material carefully removed with finishing diamonds before pre-polishing with rubber composite polishers (Figure 39). The static and dynamic occlusion was checked for high spots and interference using colored foil (Figure 40). As the core build-ups were to be used as long-term temporaries until permanent treatment of the
